FAA-AM-72-7

## EVALUATION OF A FIBERGLASS INSTRUMENT GLARE SHIELD FOR PROTECTION AGAINST HEAD INJURY

February 1972

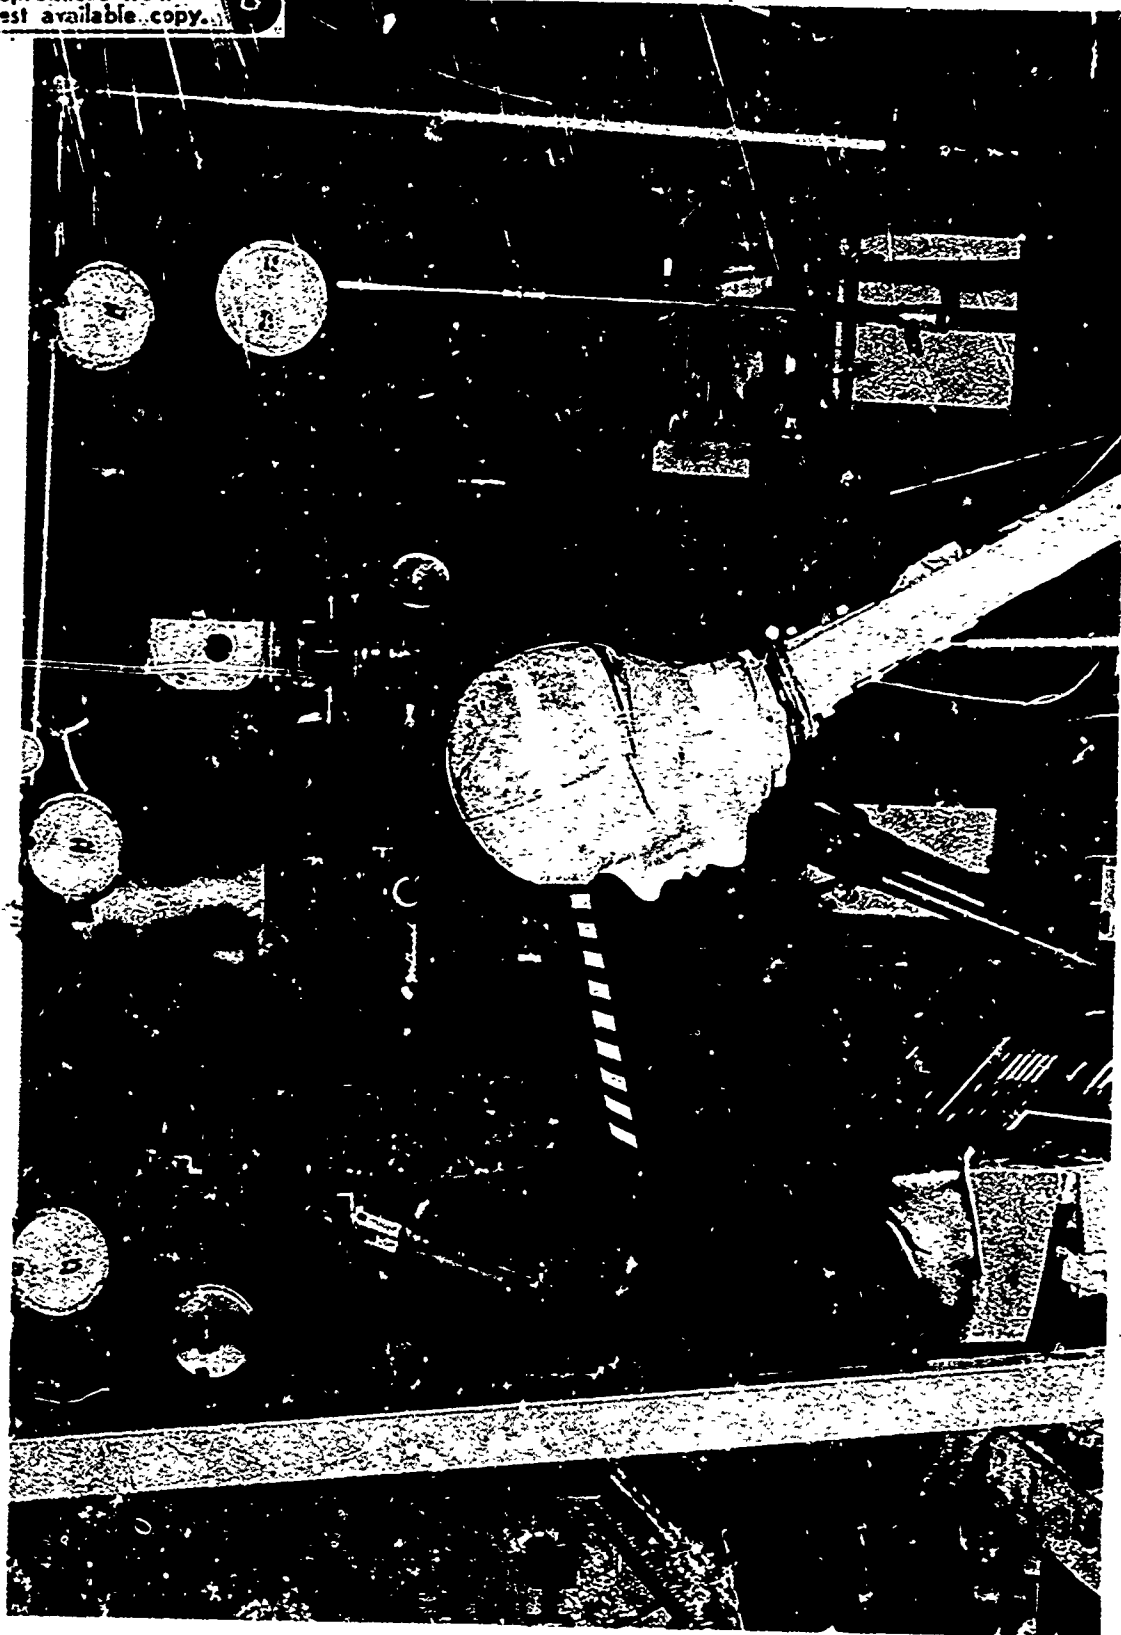
FIGURE 2. Strips of adhesive tape were added to show depth of head penetration.

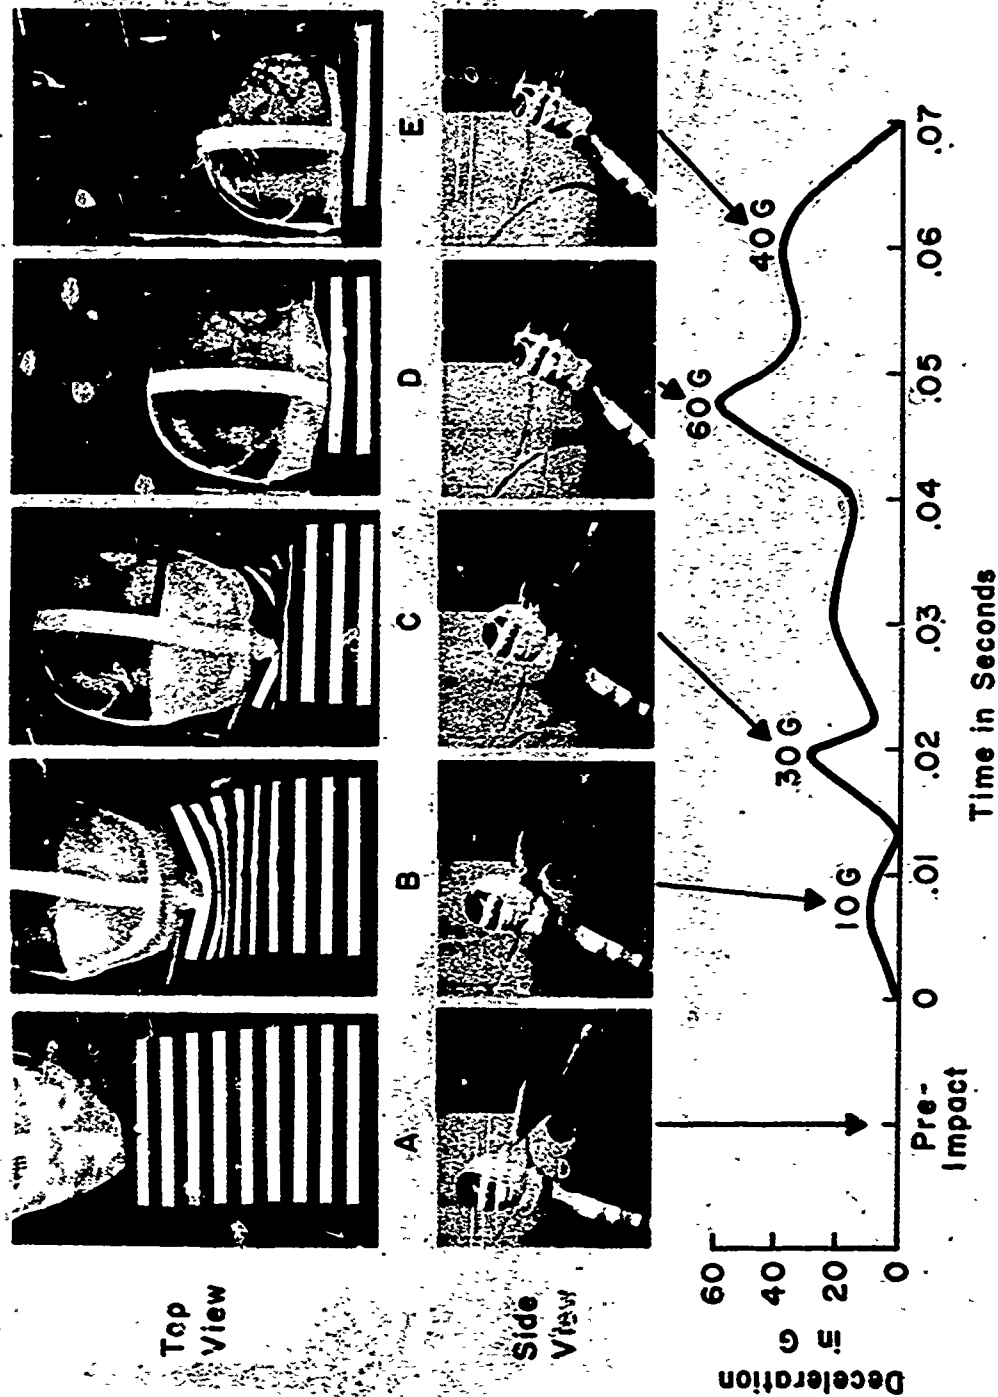
# Head Impact Test of Fiberglass Instrument Panel (Velocity = 30 ft/sec)

FIGURE 4. Results of a 30-ft./sec. head impact against the fiberglass glare shield.

Figure 4 presents a pictorial sequence of events correlated with deceleration measured during Test One (30 ft./sec. head impact velocity). The initial head contact with the edge of the glare shield was with the maxilla just below the

nose producing an initial deceleration peak of 10 G's followed by a second peak of 30 G's as the shield began to collapse. Chalk deposited on the head form from the edge of the glare shield during this phase of the impact was lifted by means of masking tape and the area of facial contact determined to be 3.75 square inches. Based on previous research,<sup>7</sup> it appears unlikely that major facial fractures would occur during this initial head impact. From 0.025 seconds to 0.04 seconds, the glare shield folded down over the instruments and prevented head contact with them. However, beginning at about 0.04 seconds, the fiberglass broke about 6½ inches from the edge of the glare shield. The thin edge of the shield, supported by the instrument panel flange penetrated the ¼-inch padding and cut the rubber head form covering, as shown in Figures 5 through 8. A peak head form deceleration of 60 G's was produced as the rigid head form contacted this thin edge. In Reference 7 it is stated that the forehead can tolerate 80 G's on one square inch without bone fracture. If we assume that the forehead contacted a four-inch length of this 0.035-inch-thick fiberglass edge, we can calculate a contact area of 0.14 square inch and any impact deceleration in excess of 12 G's would be expected to produce

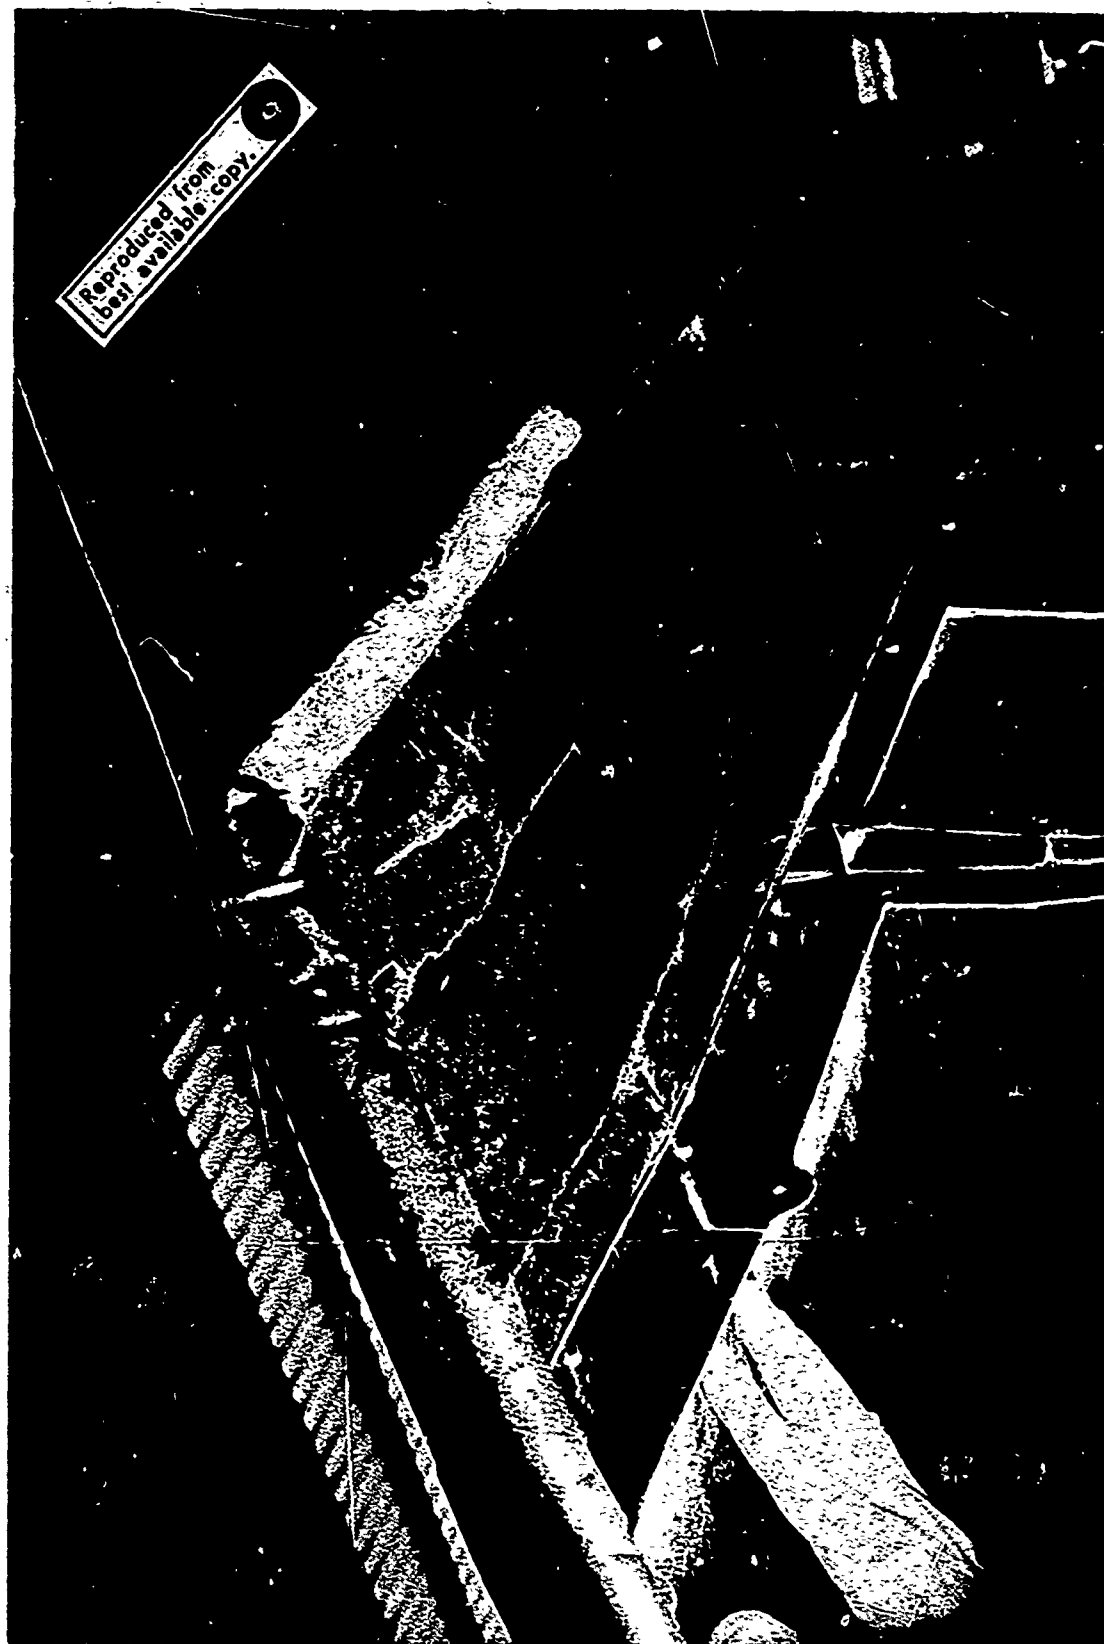
FIGURE 6. Lower view showing fractures in fiberglass.

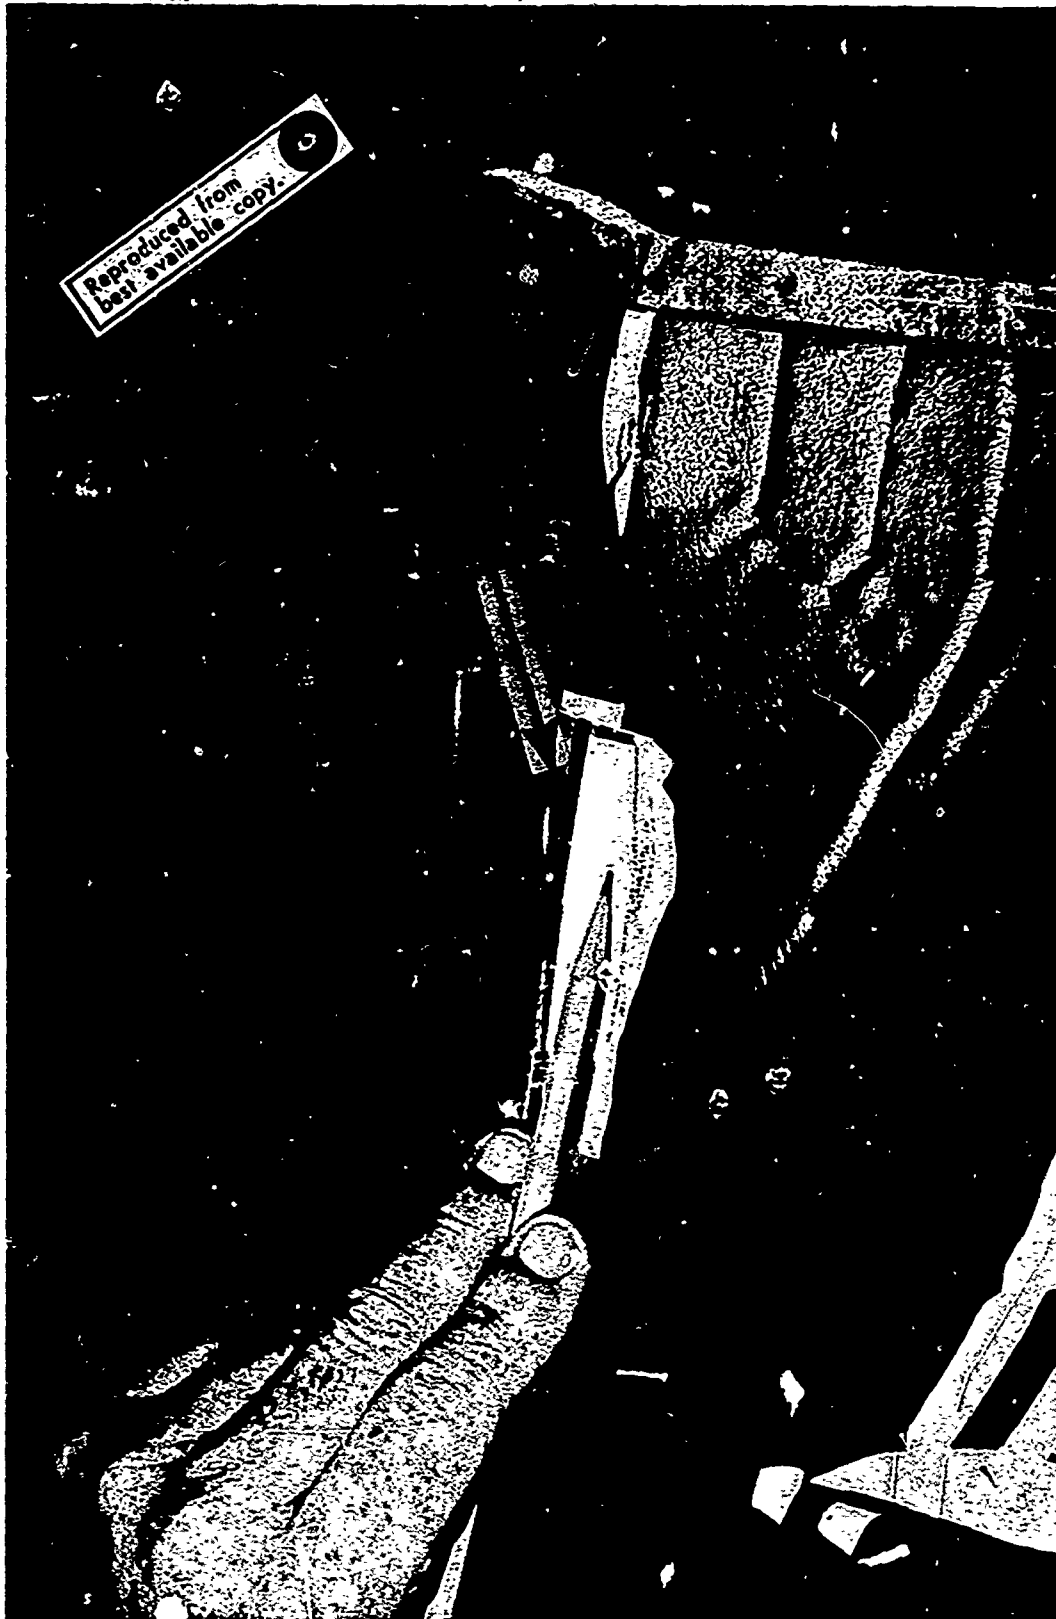
FIGURE 7. Fiberglass edge at break (see arrow). Dime is shown for thickness reference.

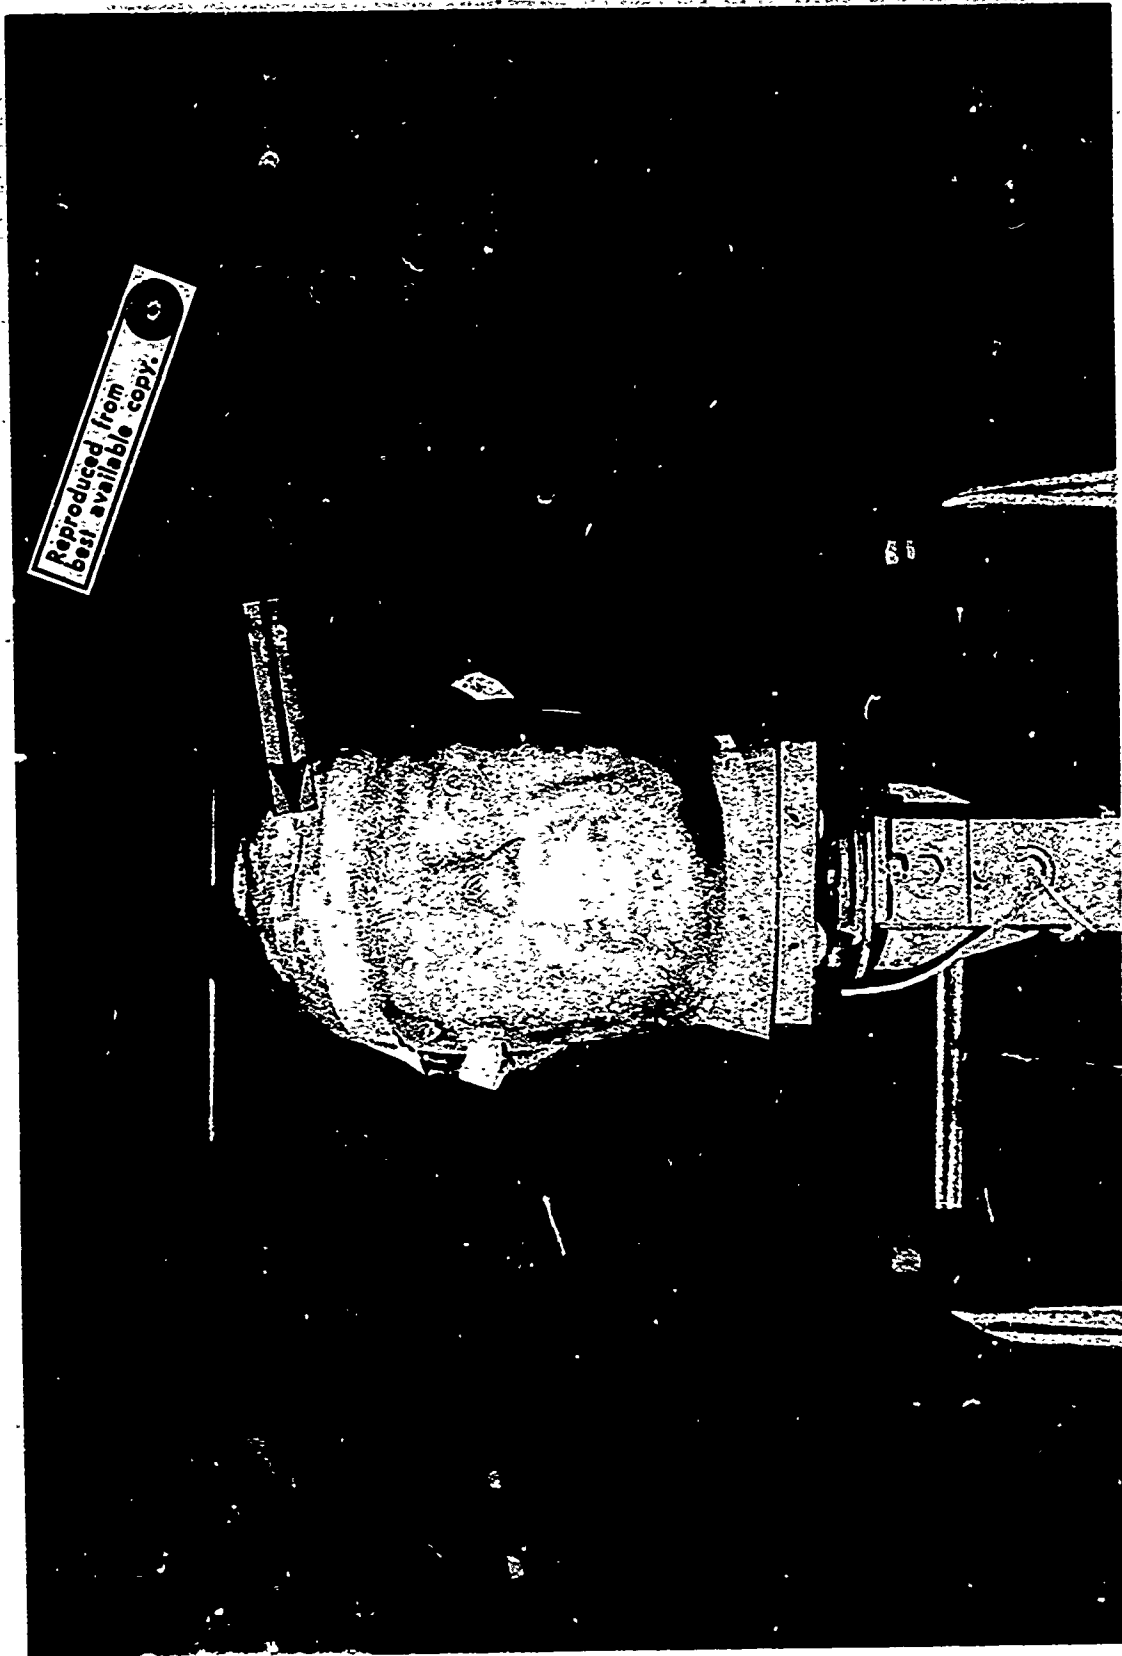
FIGURE 8. Lacerations (at arrow) in rubber covering on dummy head forehead from impacting broken fiberglass.

injuries. The impact of 60 G's in this test would produce severe lacerations (Figure 8) and extensive fracture of the anterior cranium.
